High Mullion Temperature

Regarding models: G-37, G49c

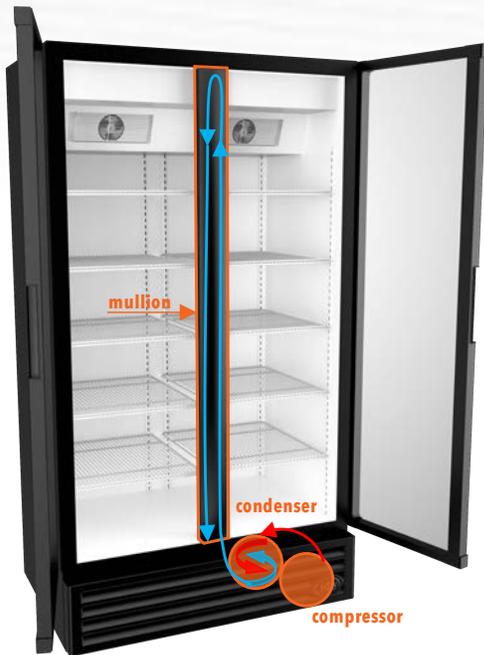
A simplified overview of the refrigerant flow in a Cooler with a mullion is as follows:

- ▶ Refrigerant runs from the compressor to the condenser, then up and down through the mullion, and back through the rest of the refrigeration system.
- ▶ The hot refrigerant line runs thru the mullion to help prevent condensation (moisture) formation on the exterior (mullion) surface in the area surrounding the door gasket(s).

Without proper airflow to remove heat from the lines in the condenser, the refrigerant temperature will be abnormally hot which will result in high temperature readings on the mullion.

- Without proper airflow, the average temperature of the mullion could potentially be over 100° F.
- With proper airflow, the average temperature of the mullion should be approx. 70° F.

* The cause of a **High Mullion Temperature** is a lack of airflow. This could be from faulty fan, if the condenser or even front/rear grills are clogged or otherwise obstructed etc.
